석면비산측정 결과보고서

- 2013년 염전생산시설(창고, 해주) 슬레이트 처리사업 -
(신안군 비금면 지당리 333-39)

한국안전환경컨설팅(주)

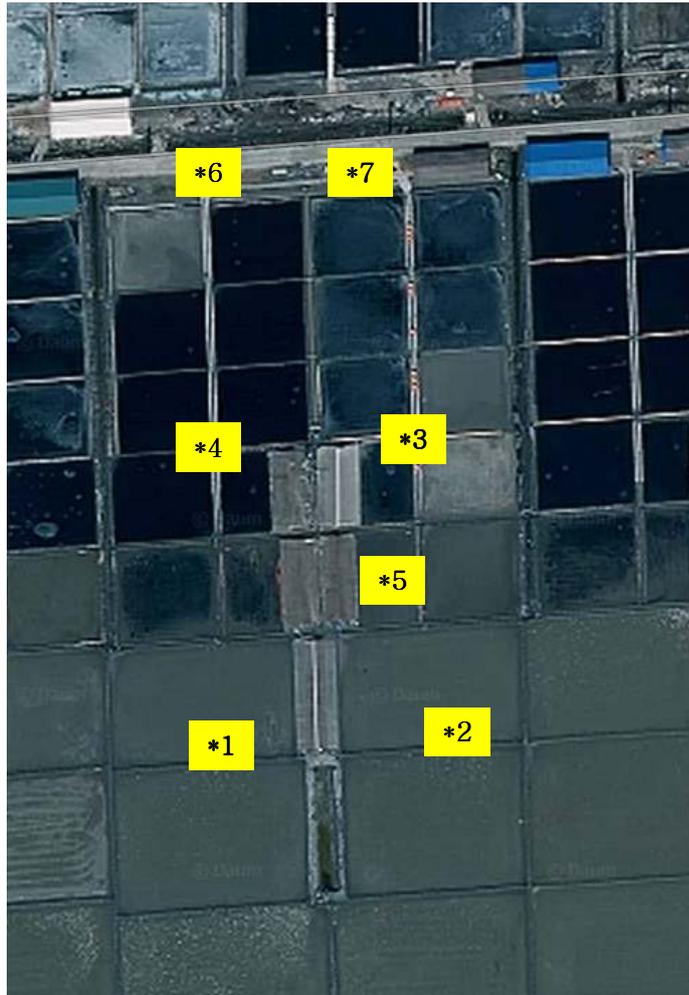
[별 첨1] 측정 위치도(측정 장소)

표 례	*NO					
	시료채취	부지경계선	대상 건축물	위생설비	폐기물야적

측정위치		측정시간(분)	유량(l/min)	측정농도 [기준: 0.01개/ cm^3]	초과여부
*1	부지경계선1	10:30 ~ 14:40	9.95	불검출 [검출한계 0.002미만]	미만
*2	부지경계선2	10:33 ~ 14:43	9.95	불검출 [검출한계 0.002미만]	미만
*3	부지경계선3	10:35 ~ 14:45	9.93	불검출 [검출한계 0.002미만]	미만
*4	부지경계선4	10:38 ~ 14:48	9.94	불검출 [검출한계 0.002미만]	미만
*5	작업장주변	10:50 ~ 13:00	9.95	불검출 [검출한계 0.002미만]	미만
*6	위생설비입구	13:10 ~ 13:55	9.93	불검출 [검출한계 0.002미만]	미만
*7	폐기물야적	14:00 ~ 14:45	9.94	0.002	미만
